FINAL REPORT
STRUCTURAL INVESTIGATION

1845 - 1902 CAPITOL BUILDING

TALLAHASSEE, FLORIDA

3 MAY 1978

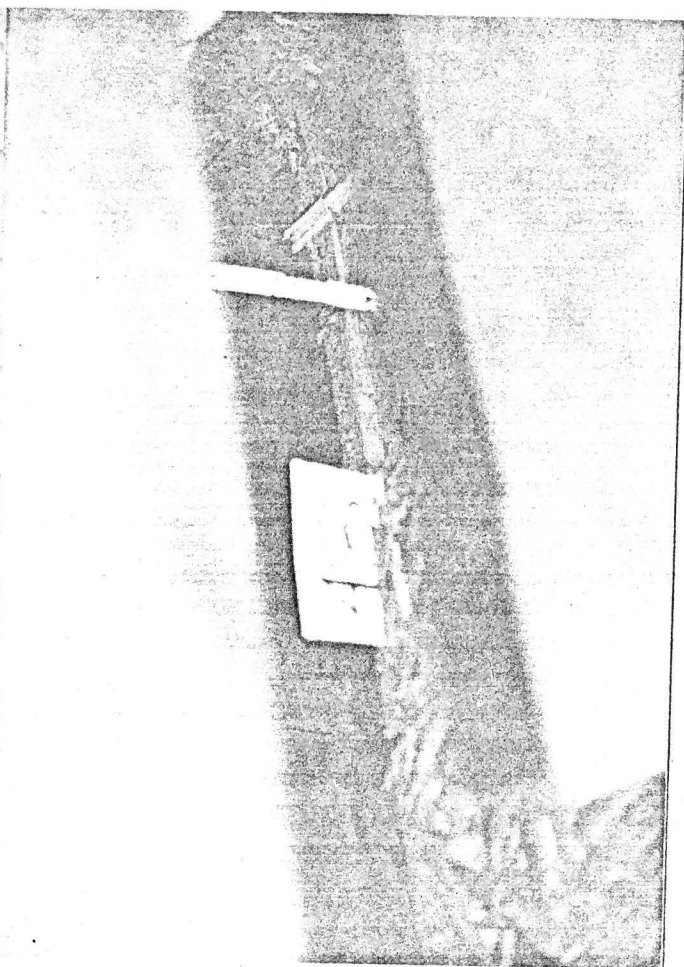
48. Rot in plate around perimeter of dome

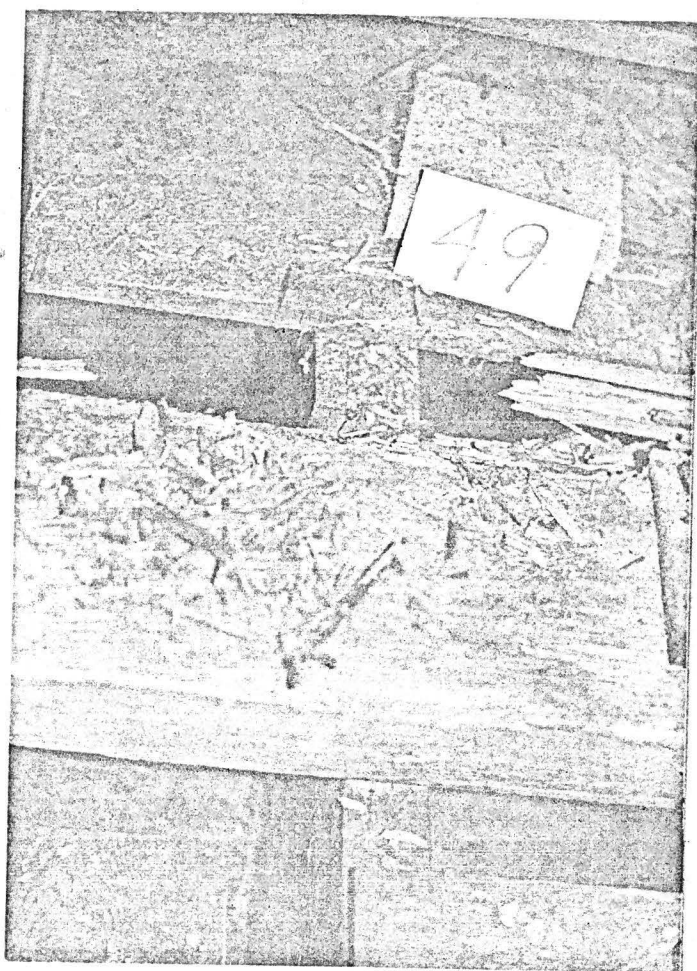
49. Wood rot in circumferential horizontal beam

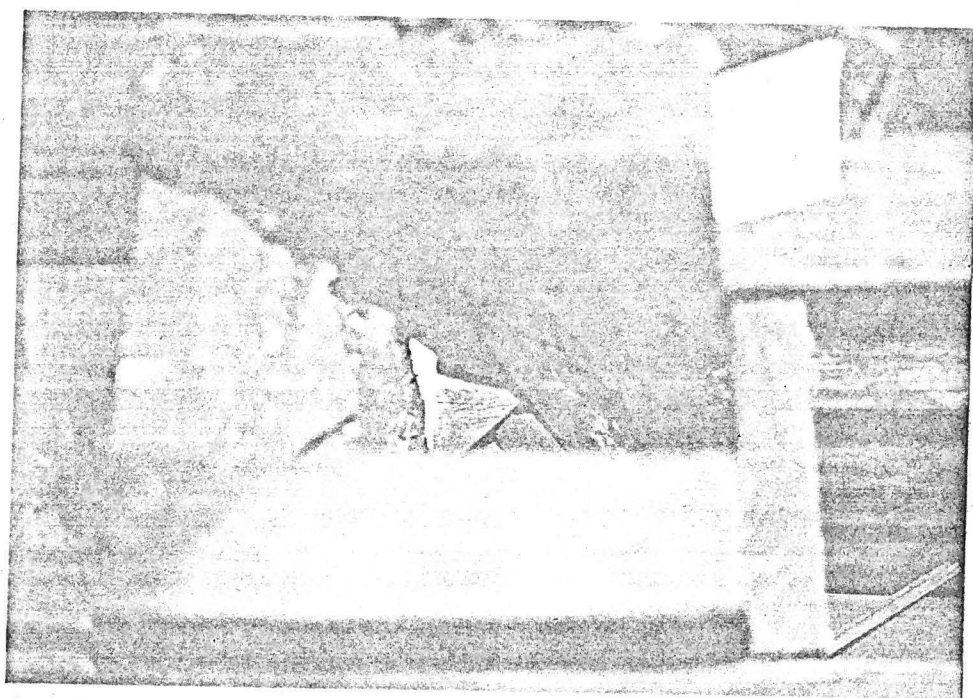
50. Wood rot in horizontal and vertical bracing

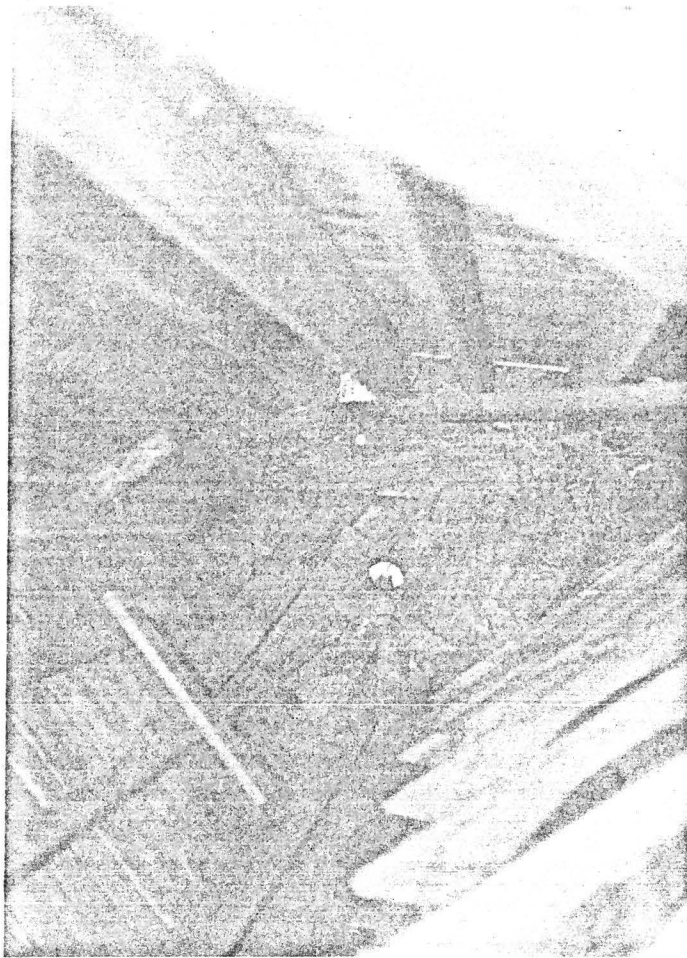
51. Debris & wood rot at bot. of dome corners

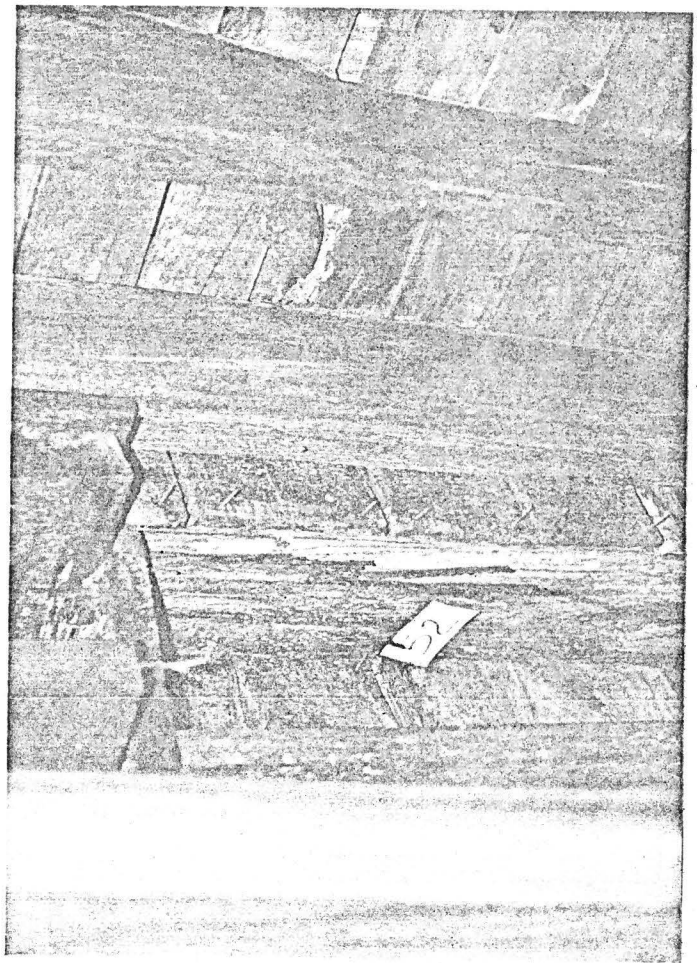
52. Severe water damage near dome corners

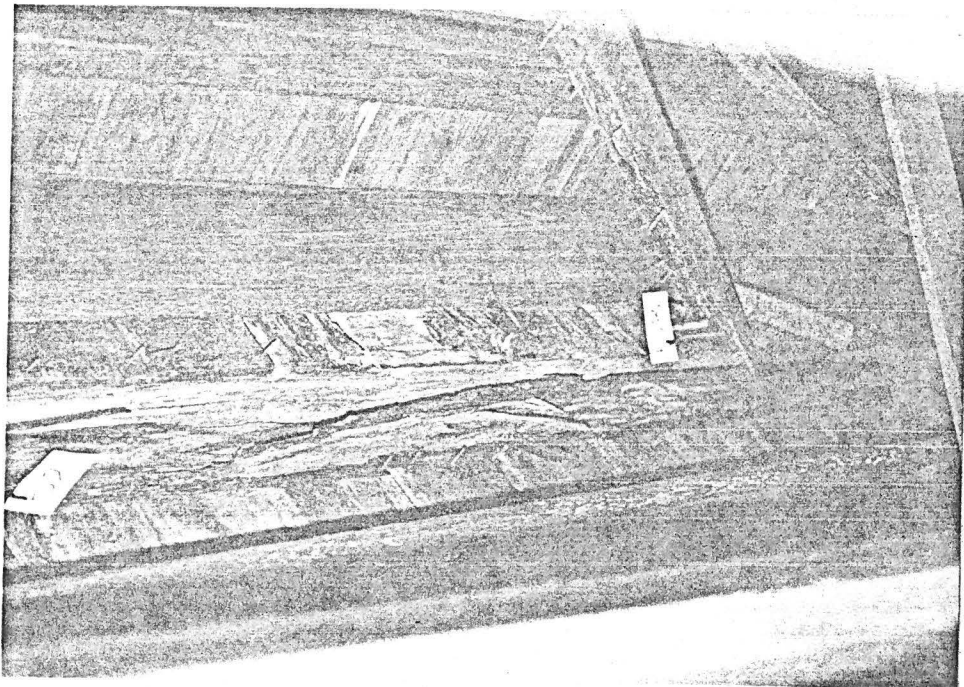
53. Severe water damage near dome corners

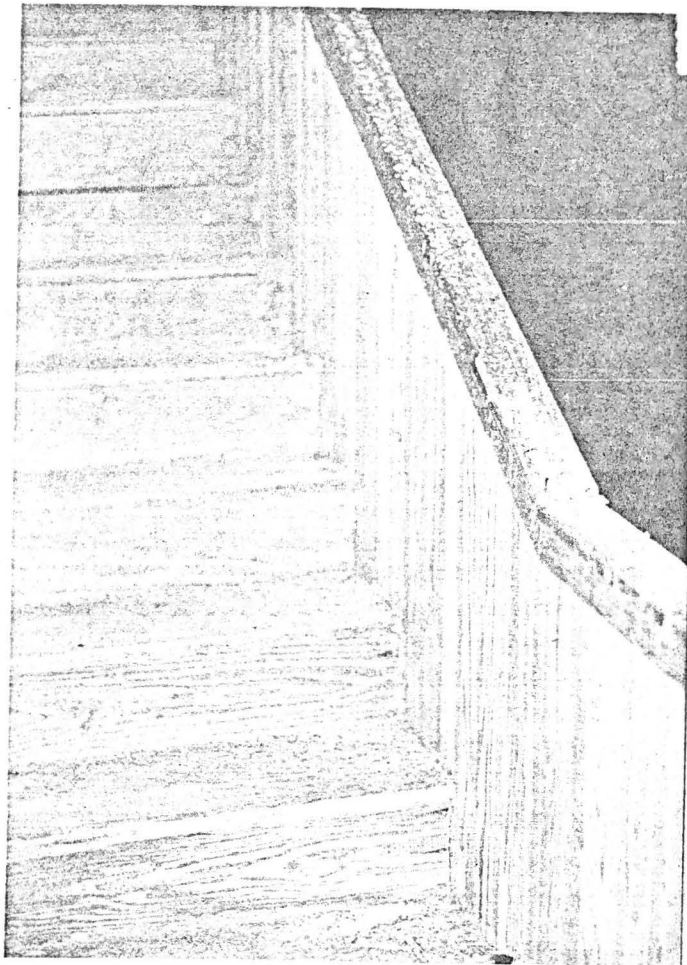
55. Borer beetle damage to stairway

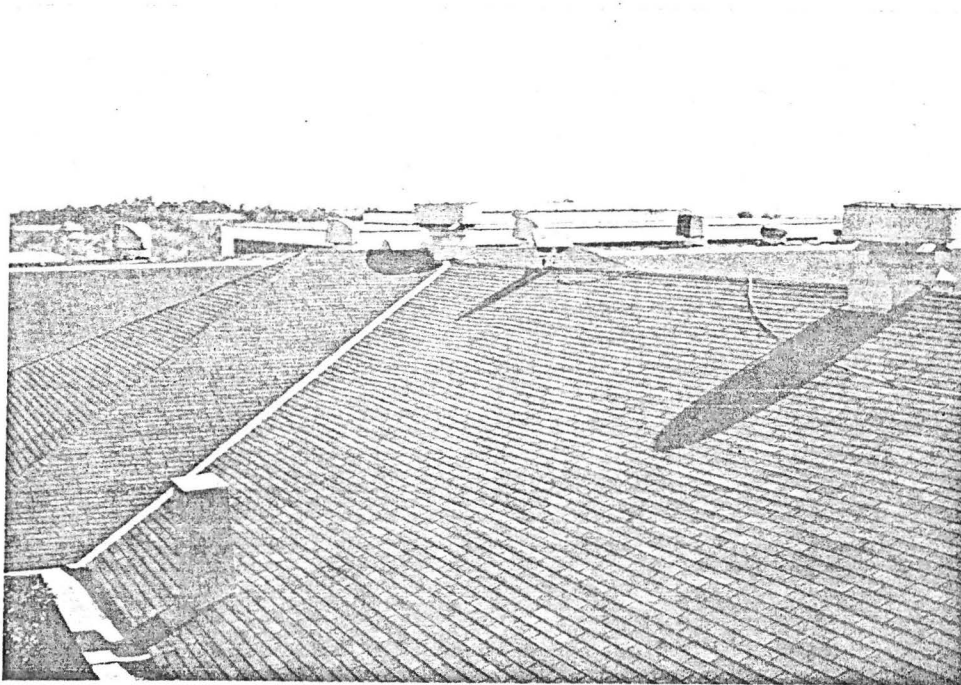
56. Sag in roof near air conditioning unit looking South

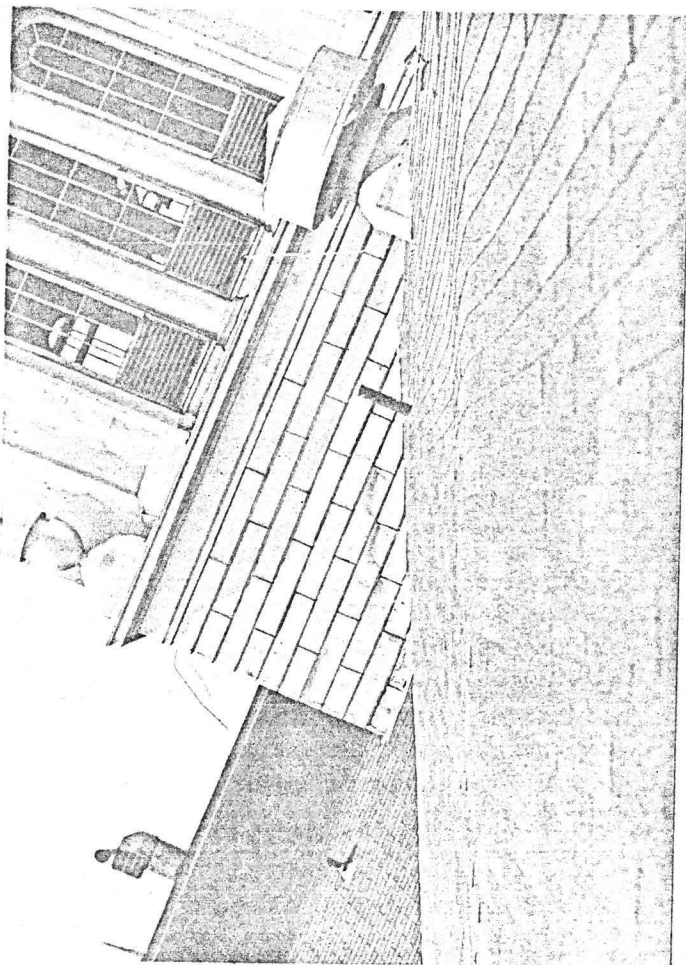
57. Sag in roof near air conditioning unit looking N.
